**2005
PROJECT
STRUCTURE REPORT**

**INSPECTION OF
FLOOD CONTROL STRUCTURES ON THE
SACRAMENTO AND SAN JOAQUIN RIVERS
AND THEIR TRIBUTARIES**

**Prepared By
The Flood Operations Branch**

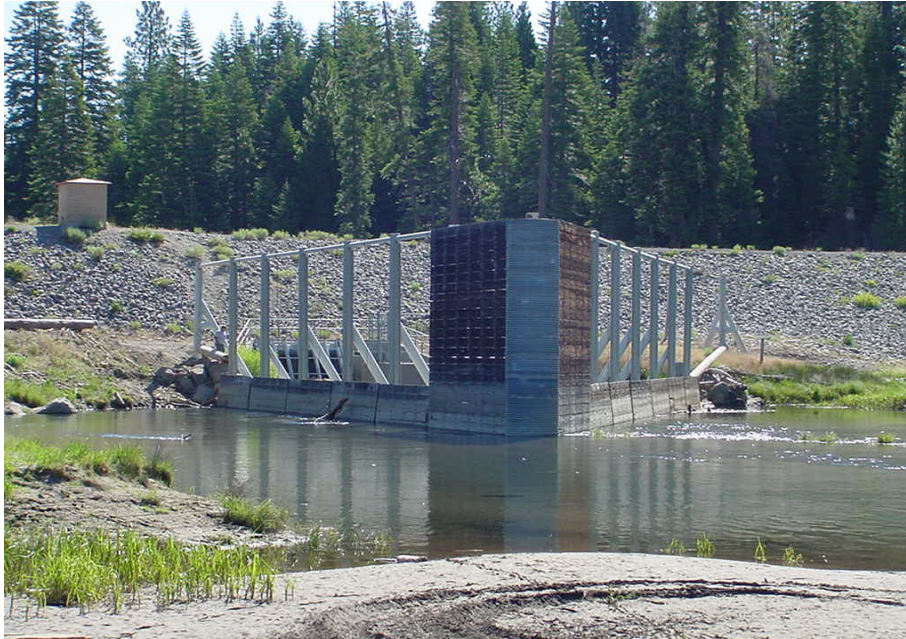
The upstream side of the diversion structure at the inlet.

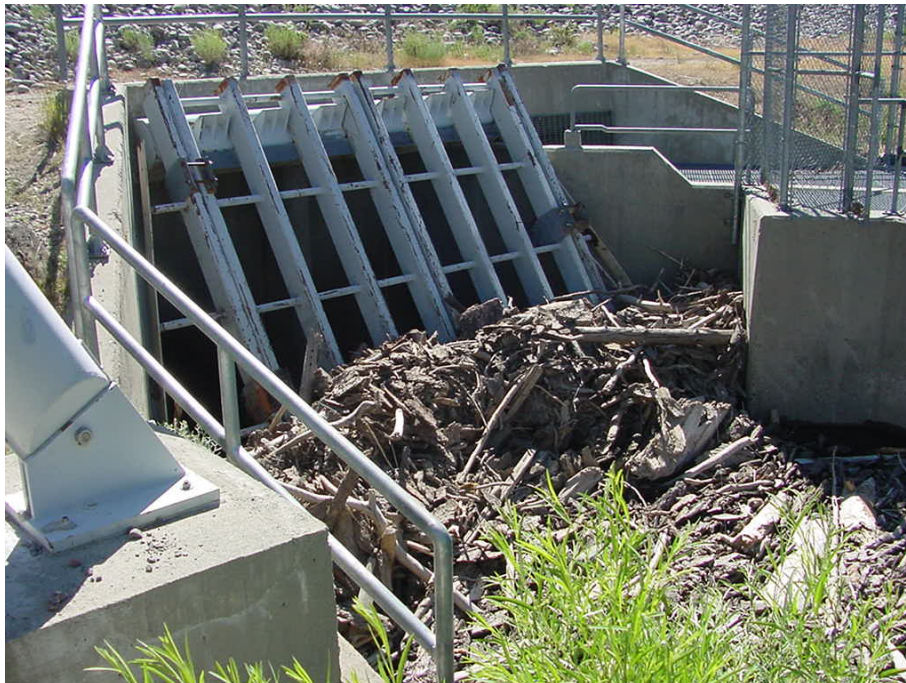
Debris partially blocking the structure inlet .

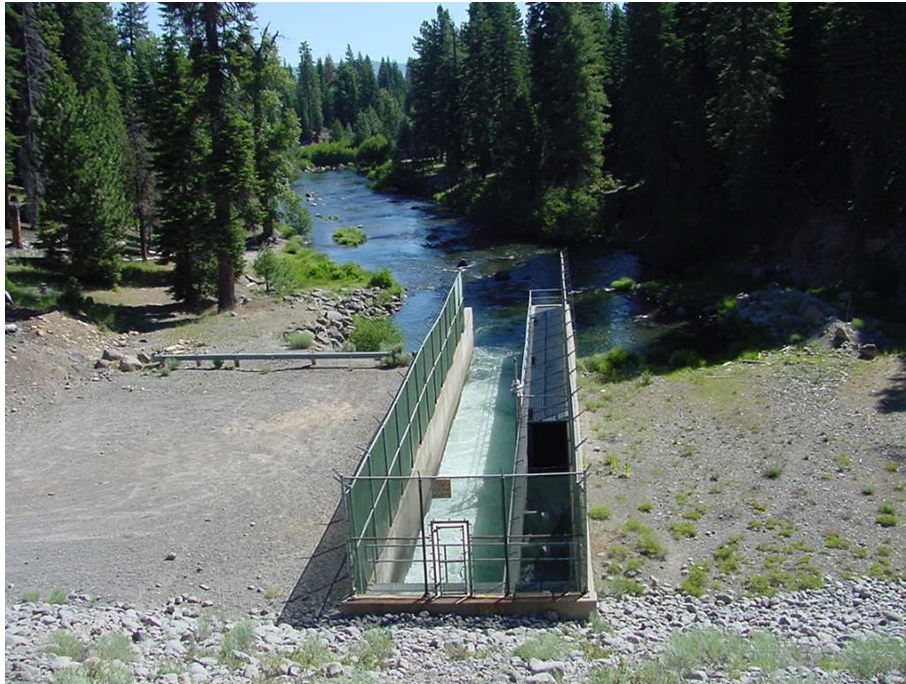
The outlet works from the top of the dam.

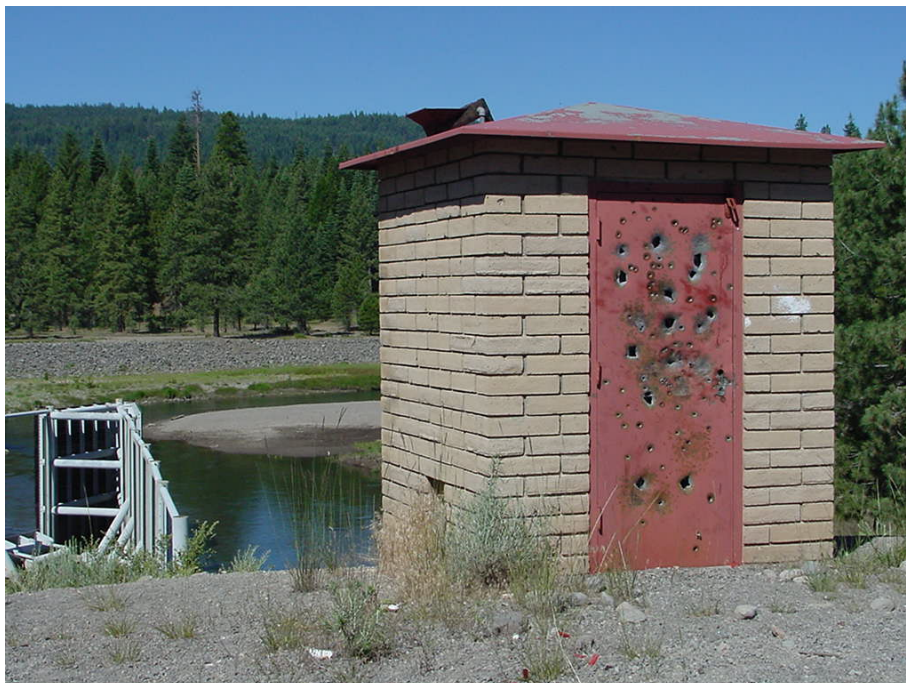
**Use of the gauging house has been discontinued
by Plumas County due to continued vandalism.**

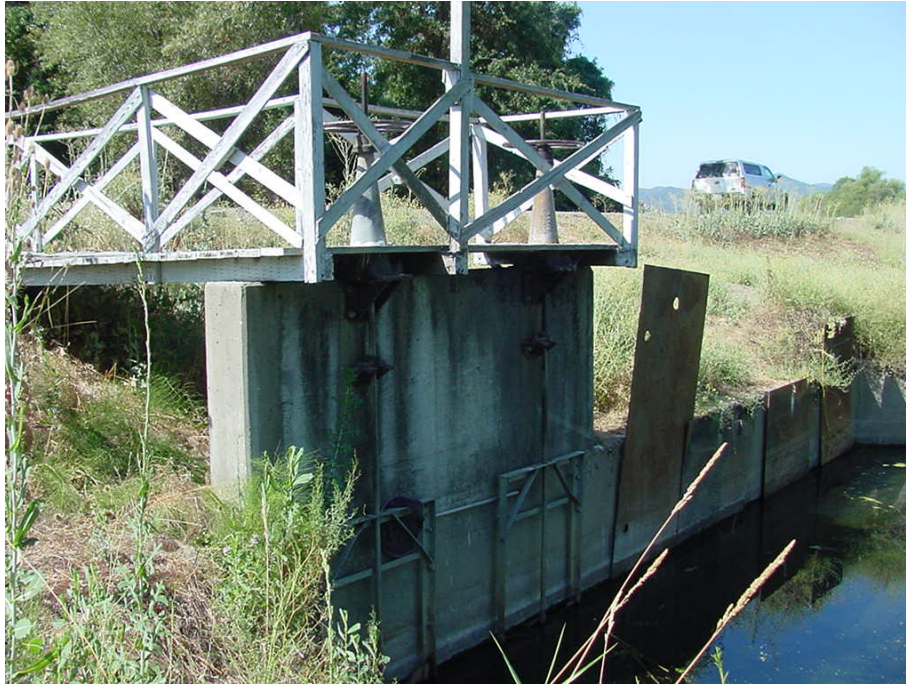
View of the diversion structure gates at the intake.

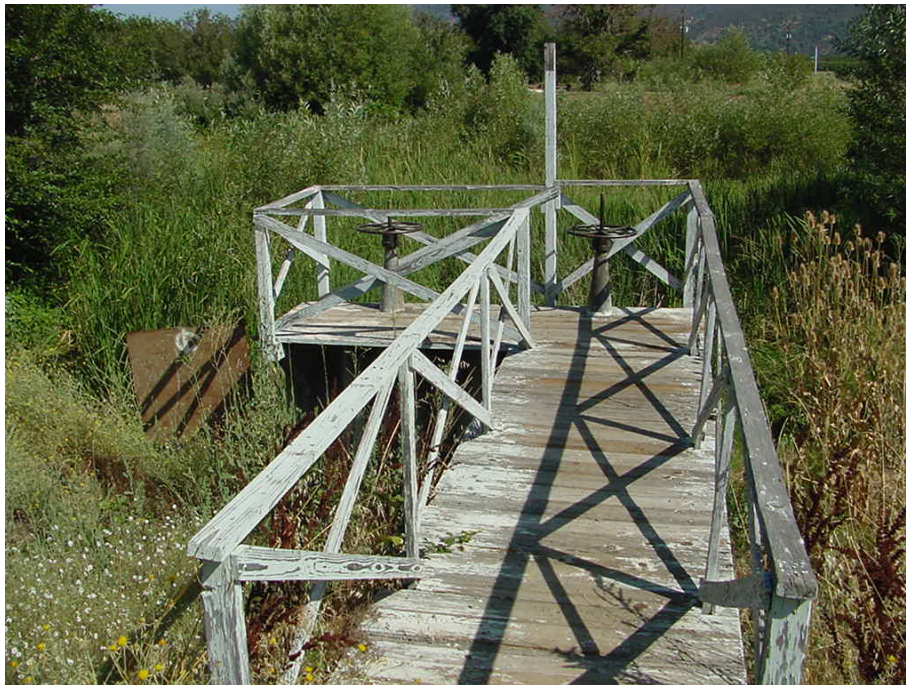
Walkway and control gate mechanisms.

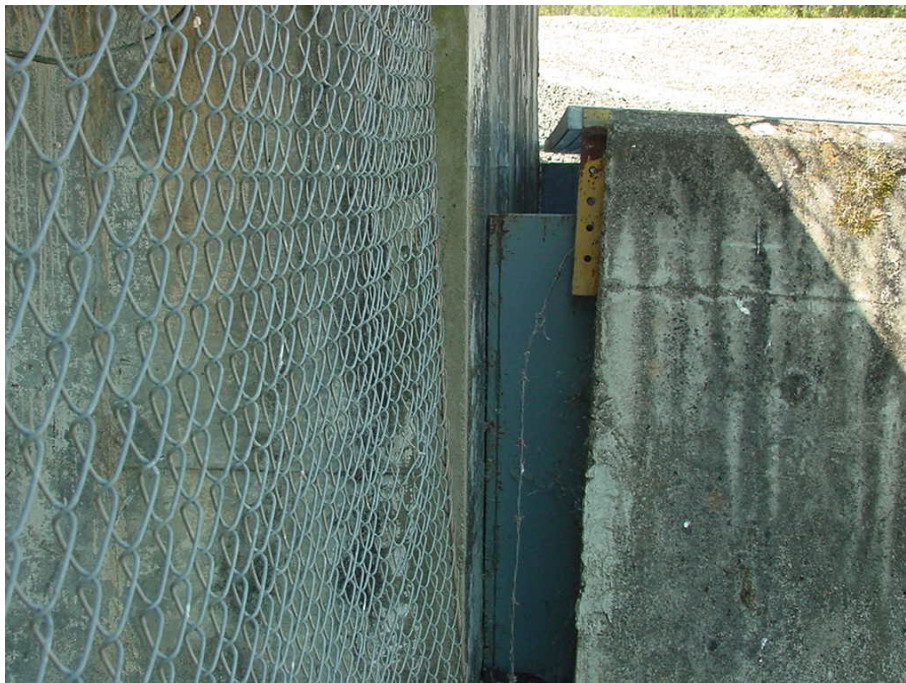
1. **Condition of main pump structure and switchboard house.**
 - a. **Poor. The separation between the top of the surge box and the structure appears to have an eight and one half inch side displacement. The surge chamber has settled twelve inches since 1962 and is 7.6 feet below the top of the structure. There is approximately a two inch deflection. There have been no changes since last reported.**

**8.5 inch side displacement between
the structure and the surge chamber.**

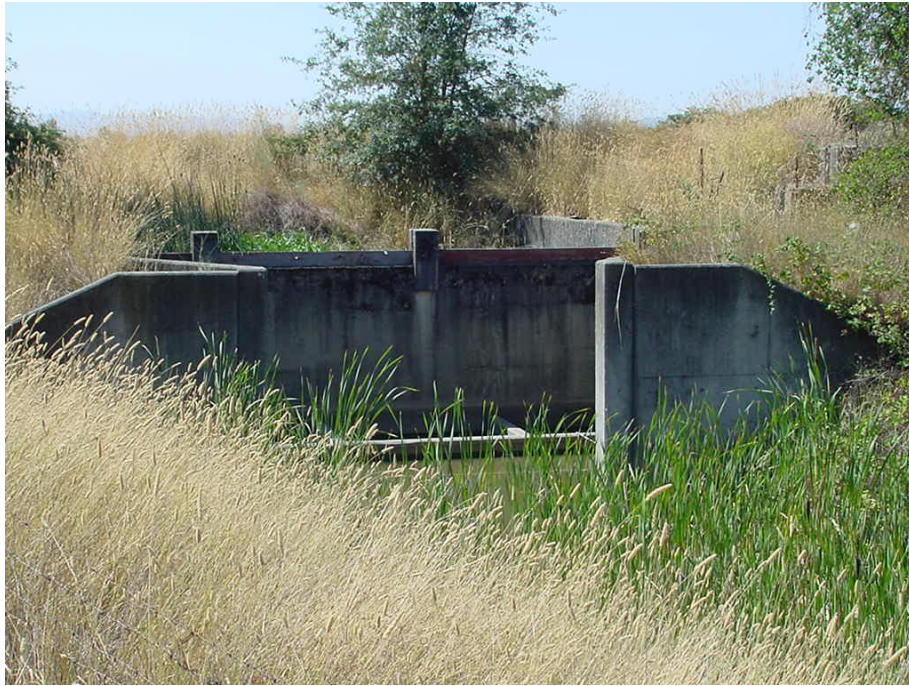
The concrete weir and diversion pipe intake.

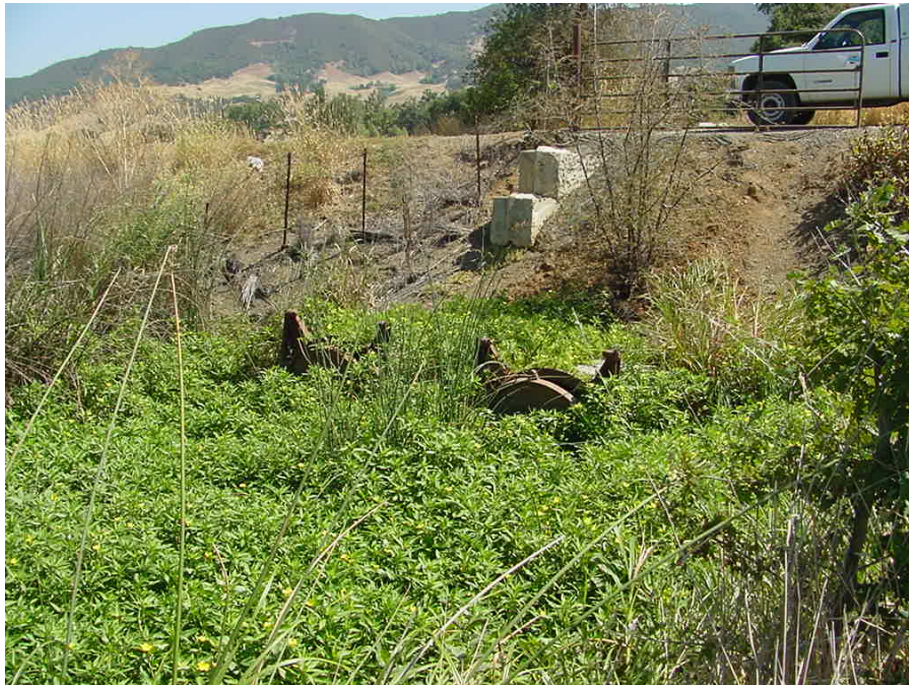
View of the outlet pipes and channel.

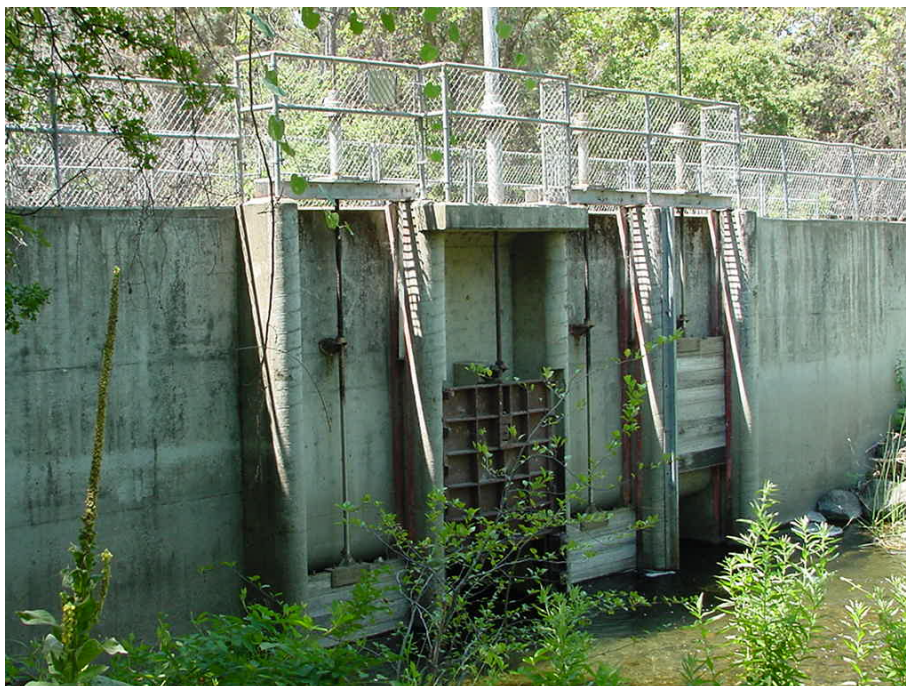
View of the upstream side of the structure.

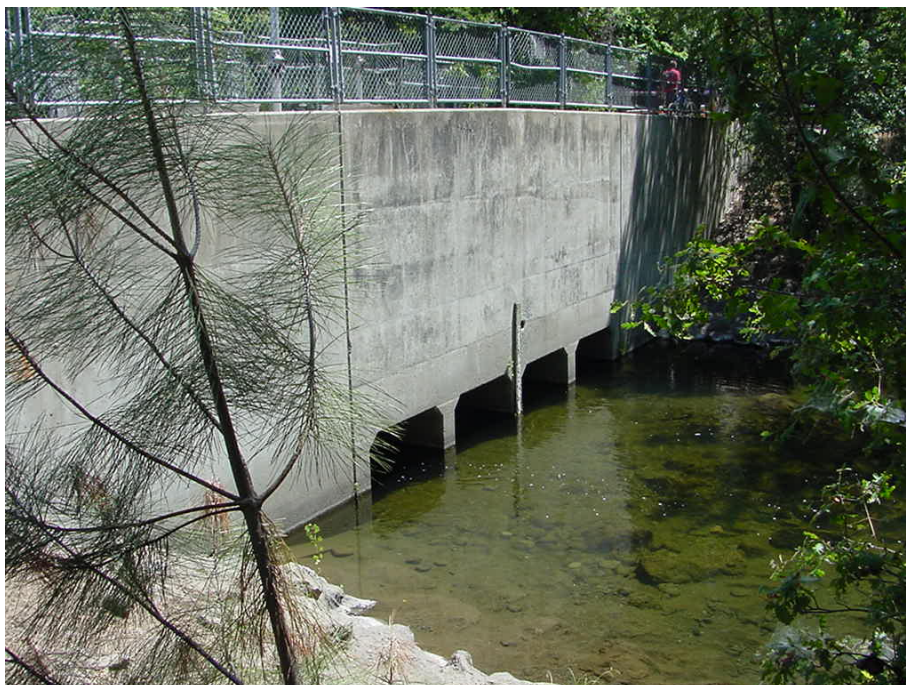
Downstream at discharge end of structure from the right bank.

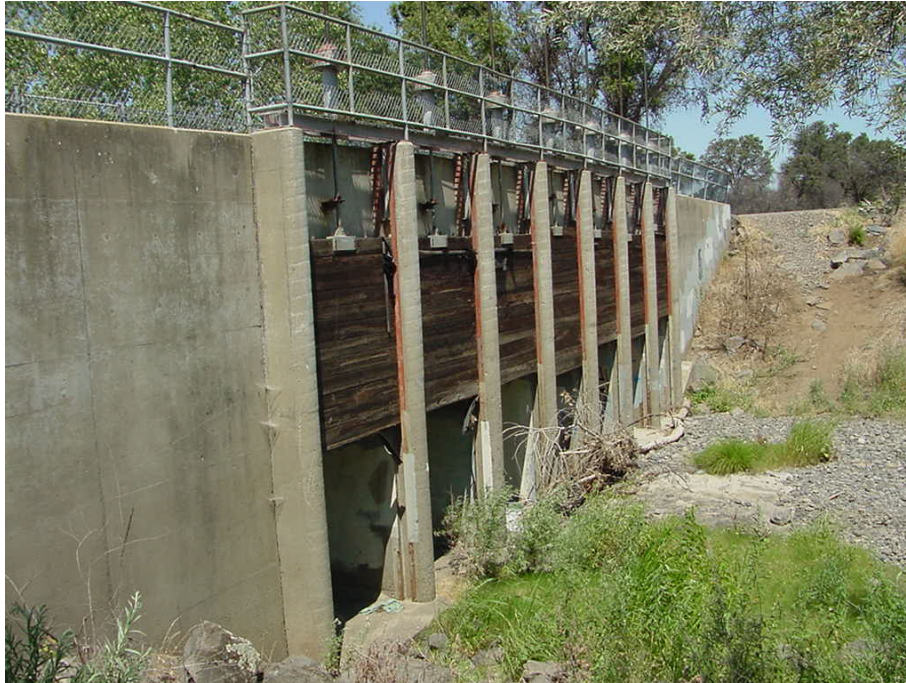
View of the upstream side of structure.

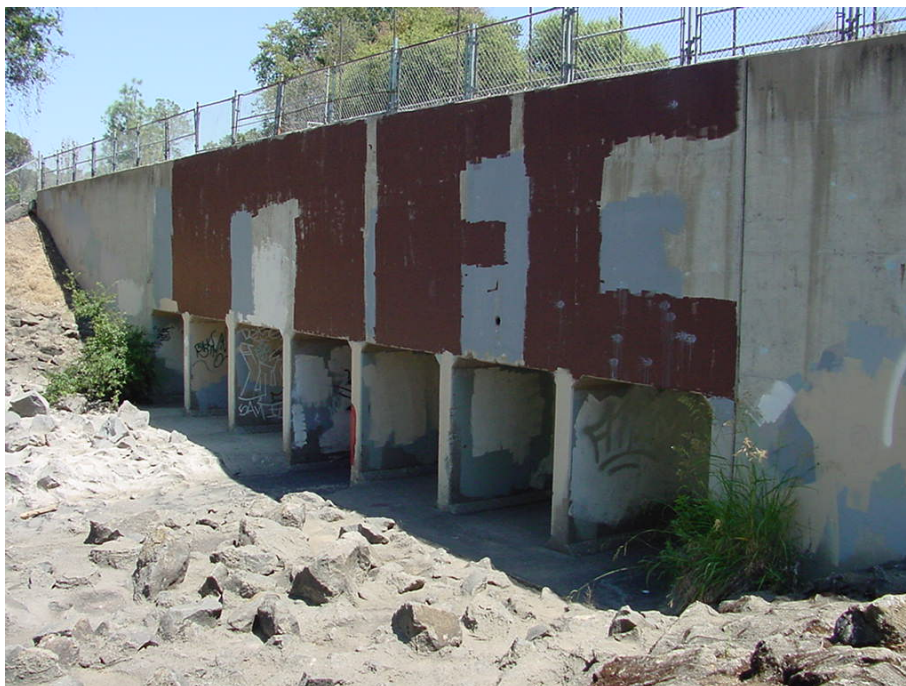
View of the downstream side of structure.

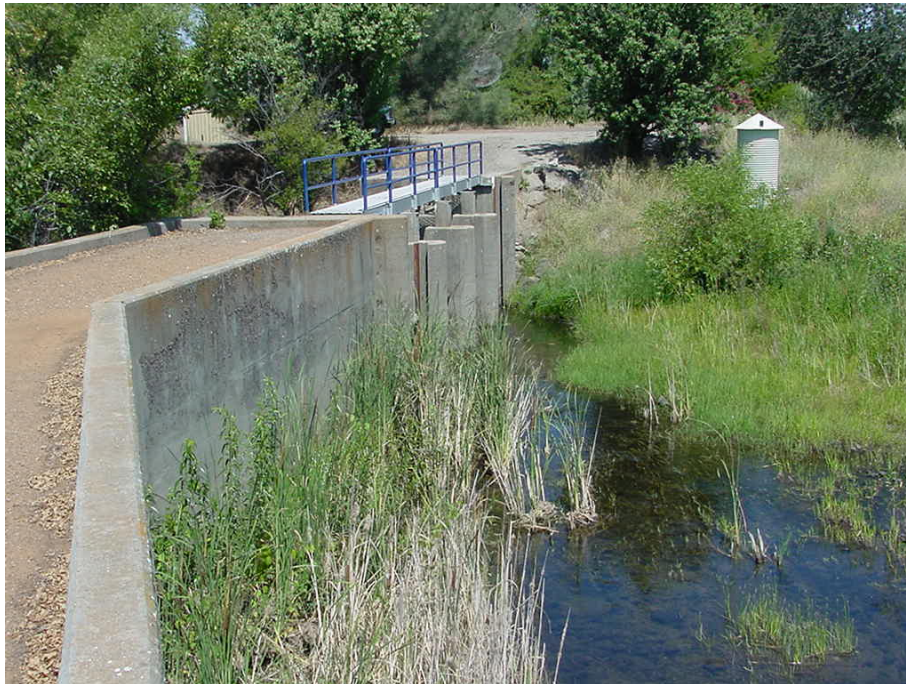
View of the upstream side of the control structure and gauge.

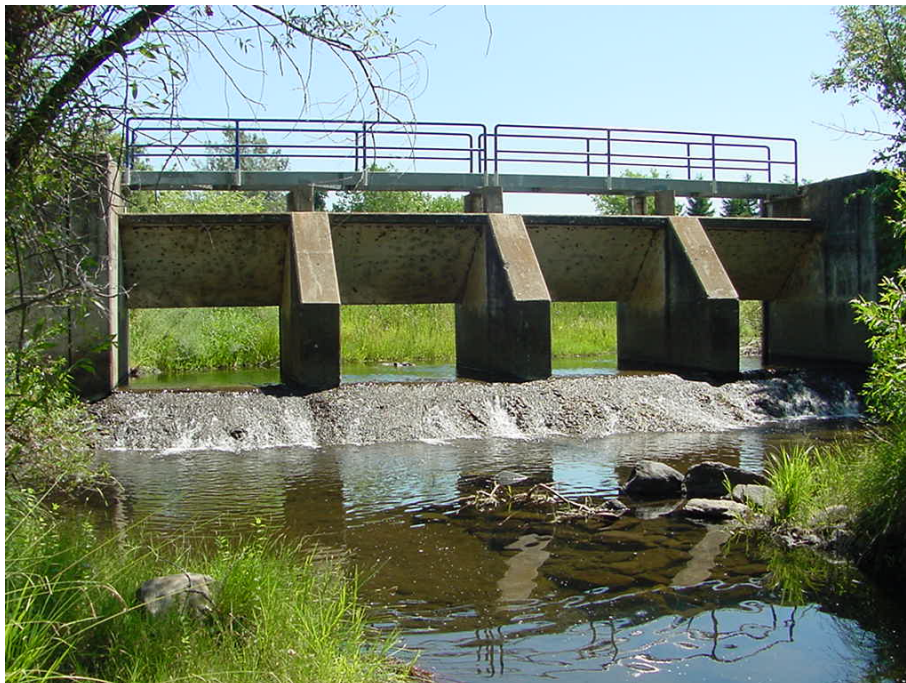
View of the downstream side of the control structure.

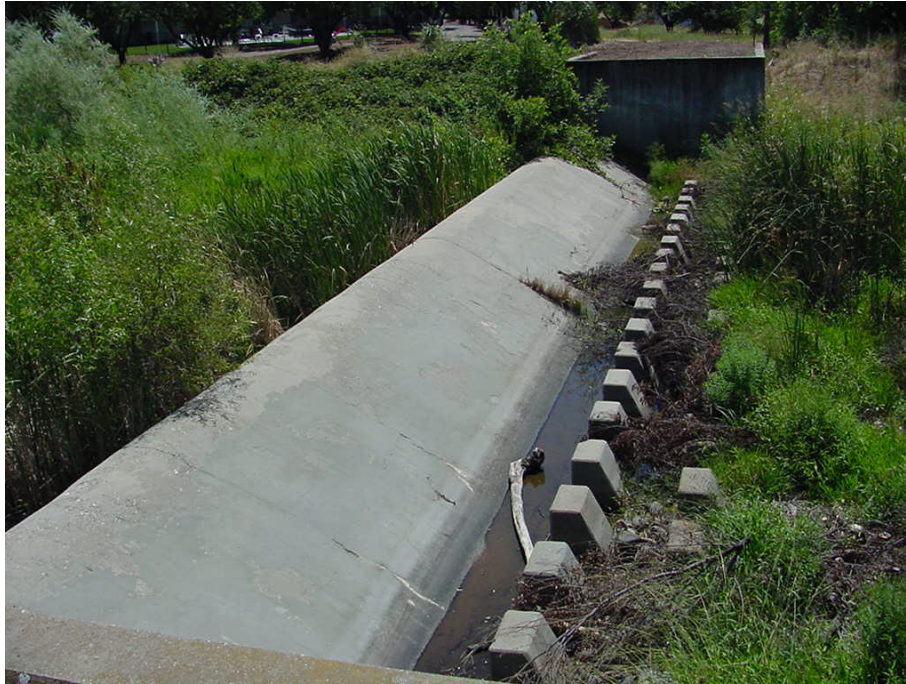
- 3. Condition of concrete weir, stilling basin, and velocity dissipaters.**
 - a. Minor cracks in the weir and minor spalling of concrete on the weir invert.**

The weir and velocity dissipaters.

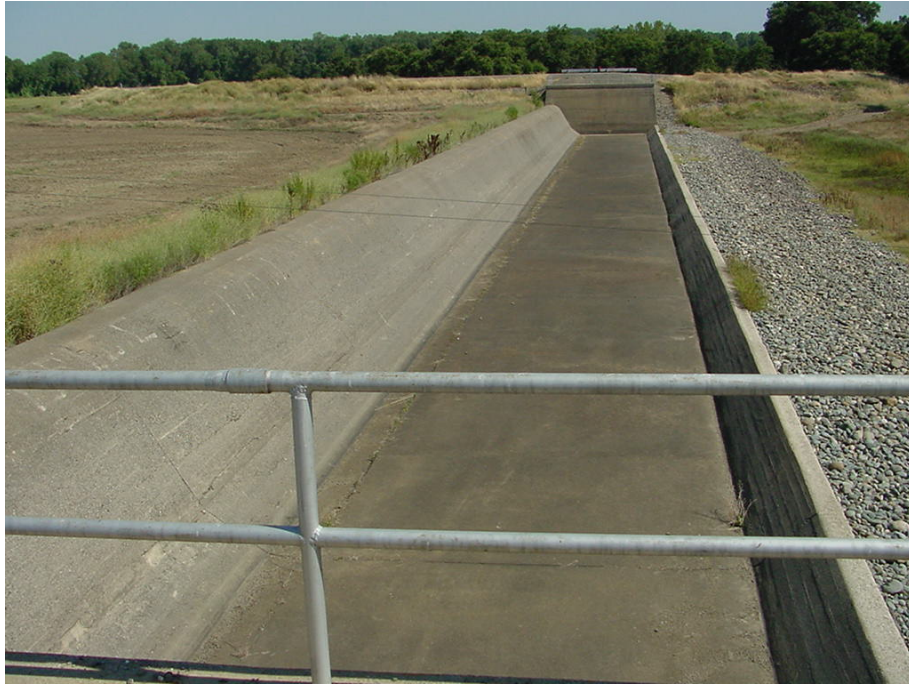
The weir and stilling basin from the top of the south abutment.

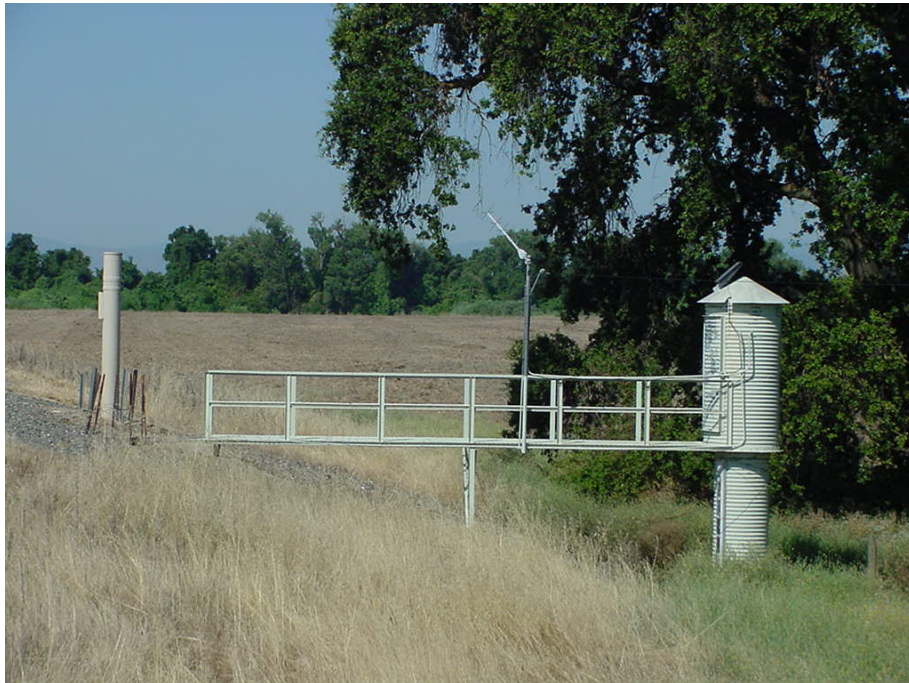
View of the gauging house directly upstream of the weir.

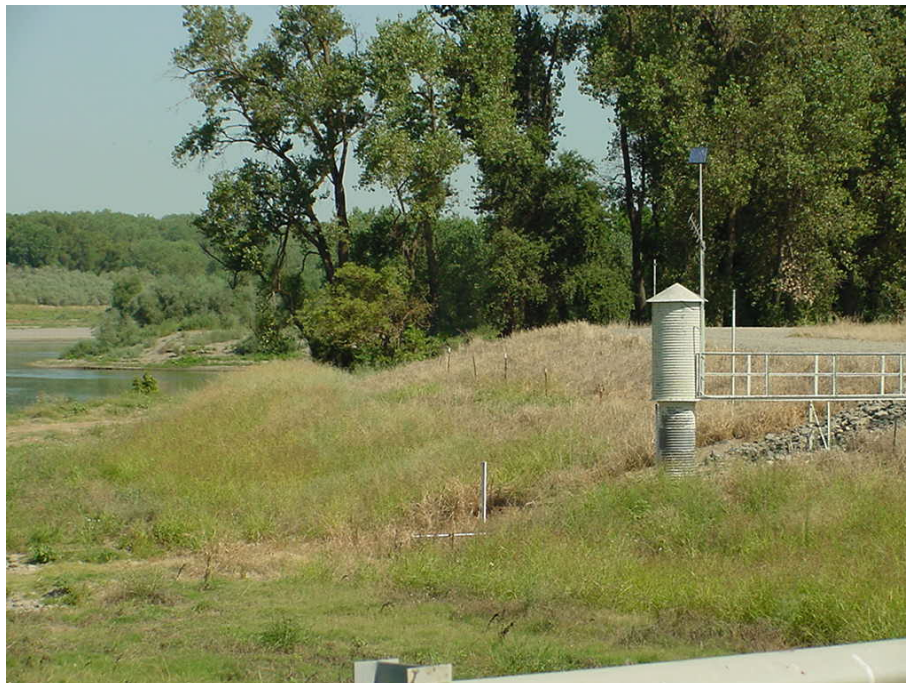
**View of the gauging house.
Sacramento River is in the background.**

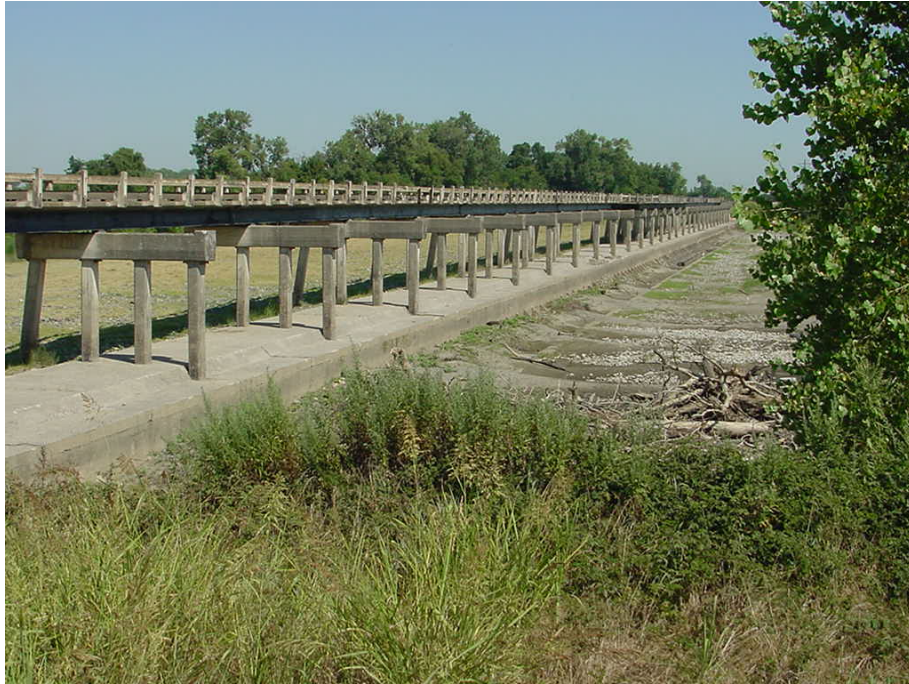
Upstream side of the weir from the south end.

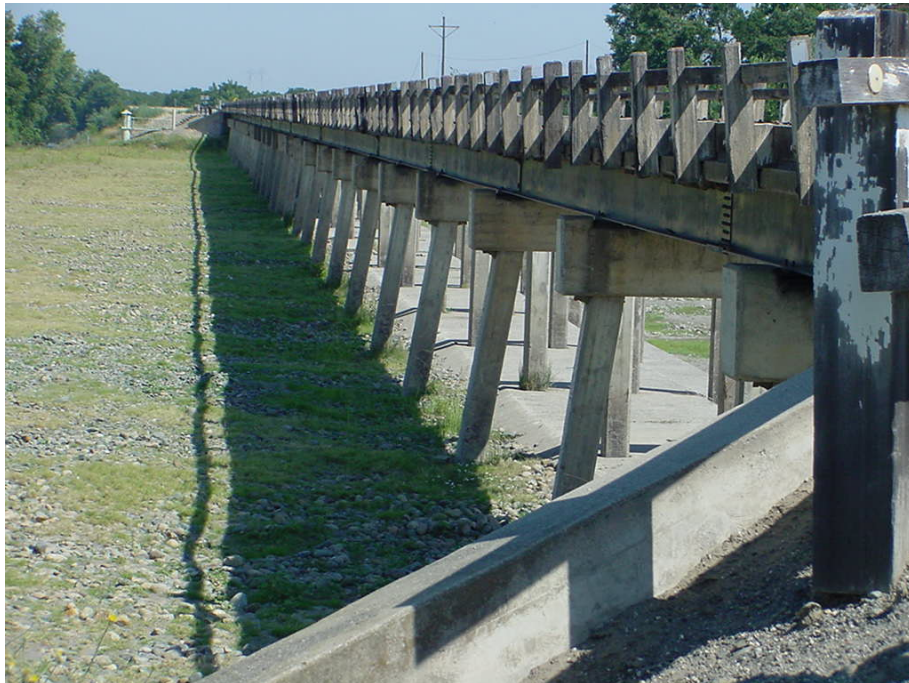
Downstream side of the weir from the south end.

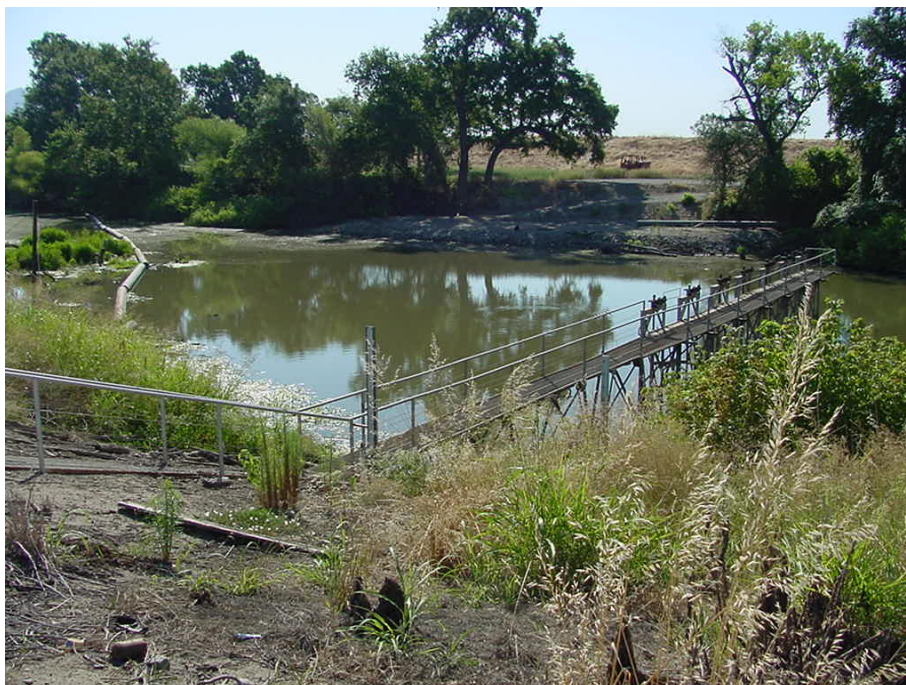
The intake side of the structure.

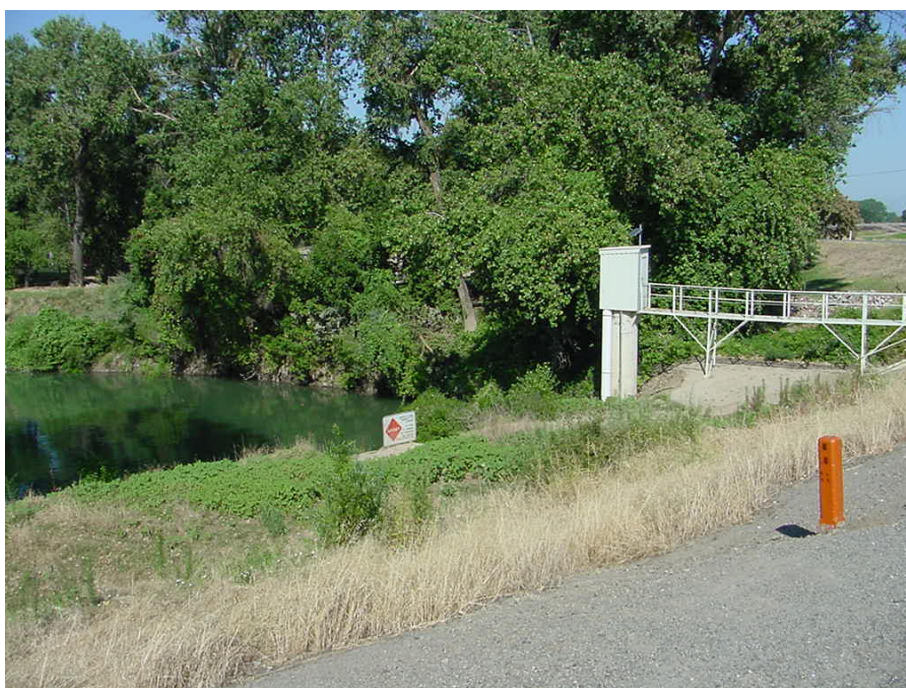
View of the outlet channel and the gauge house.

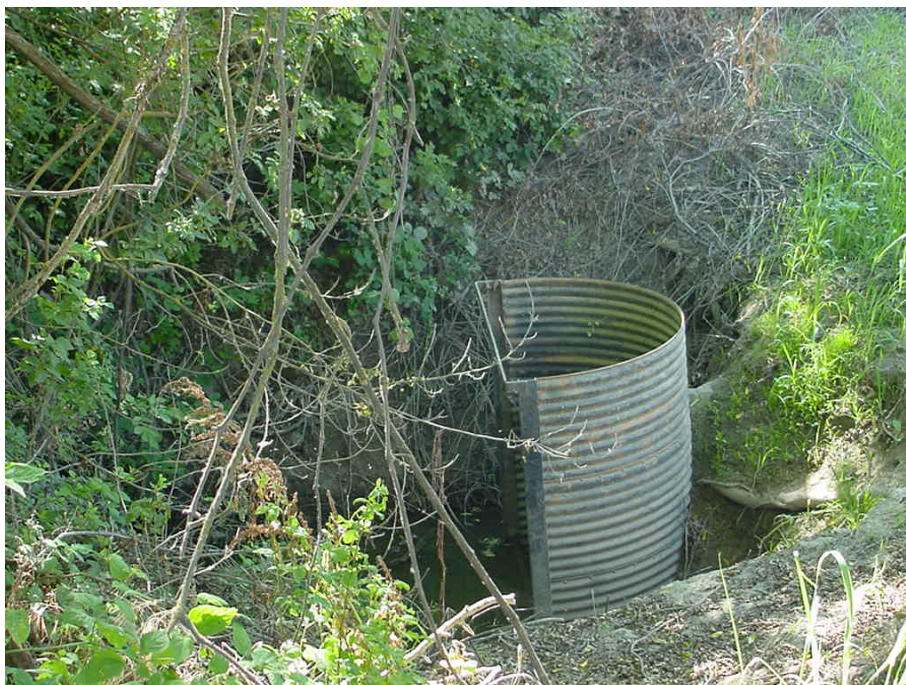
Partial CMP stand pipe protects the inlet.

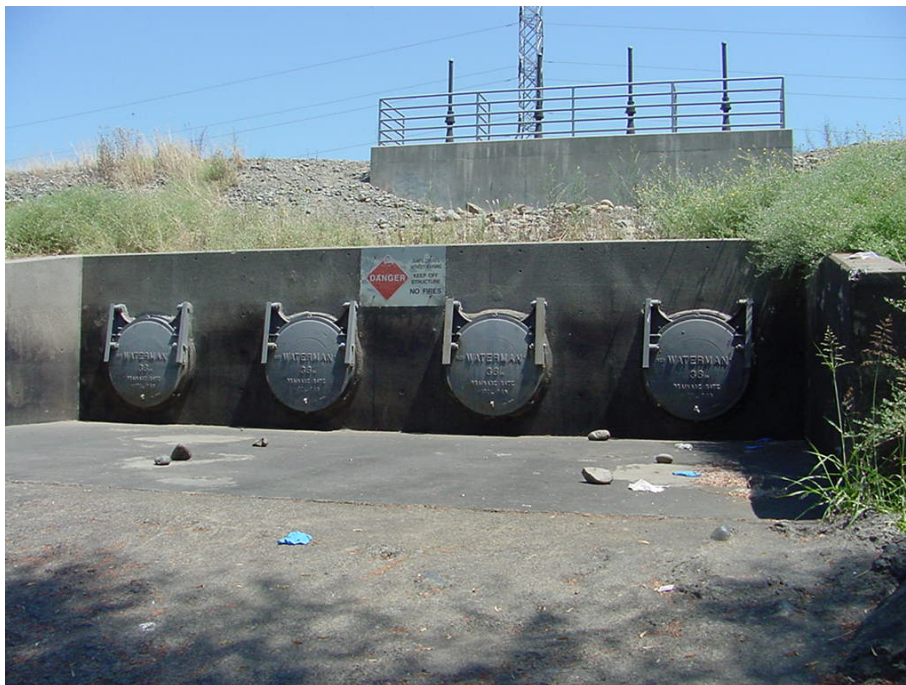
The discharge side of the pumping plant.

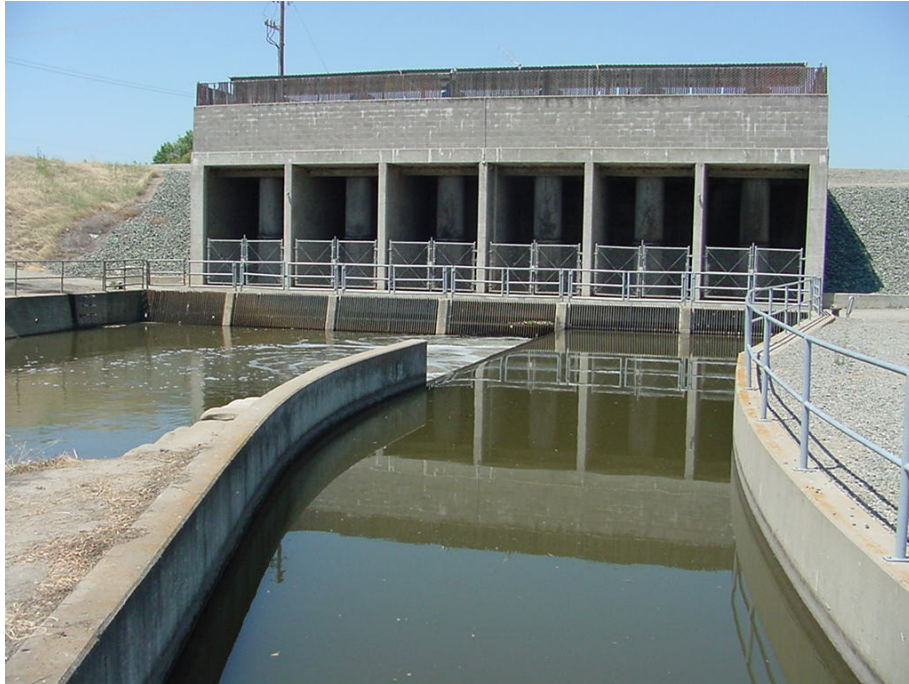
The pumping plant, sump and trash racks from the intake side.

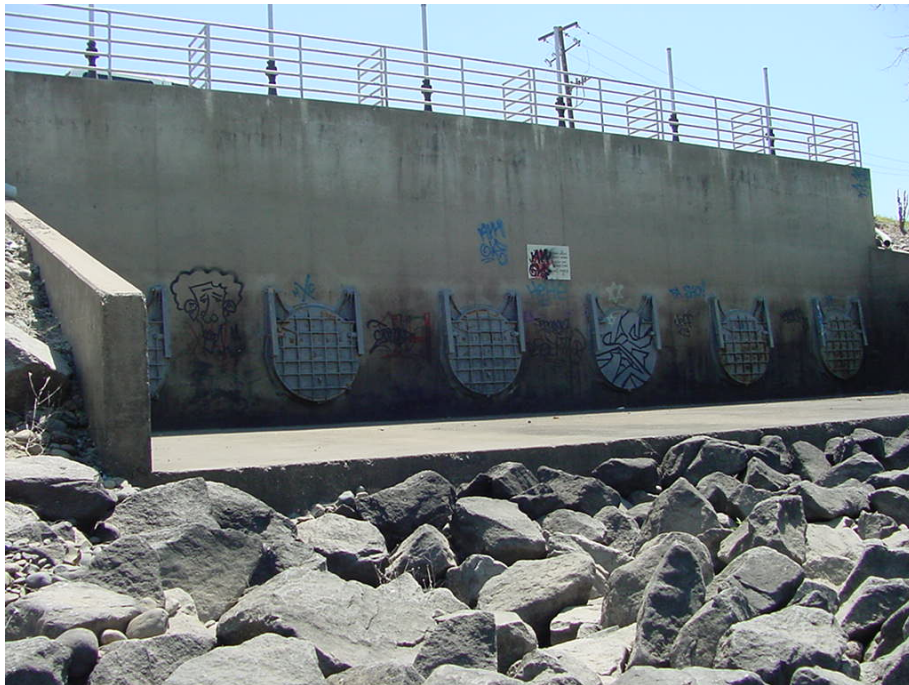
The discharge side of the pumping plant.

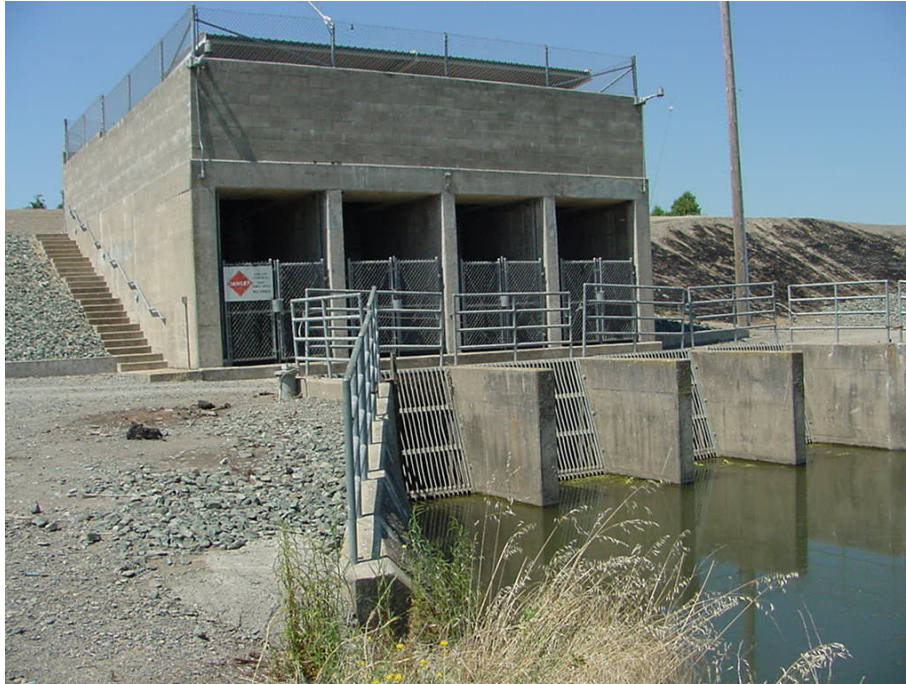
The inlet side of the pumping plant.

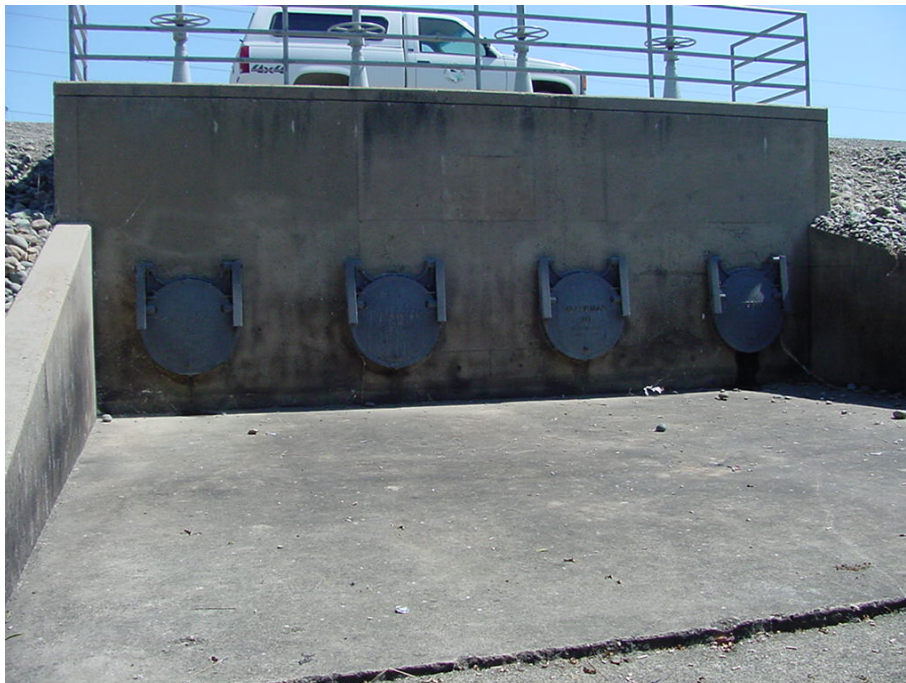
The discharge side of the pumping plant.

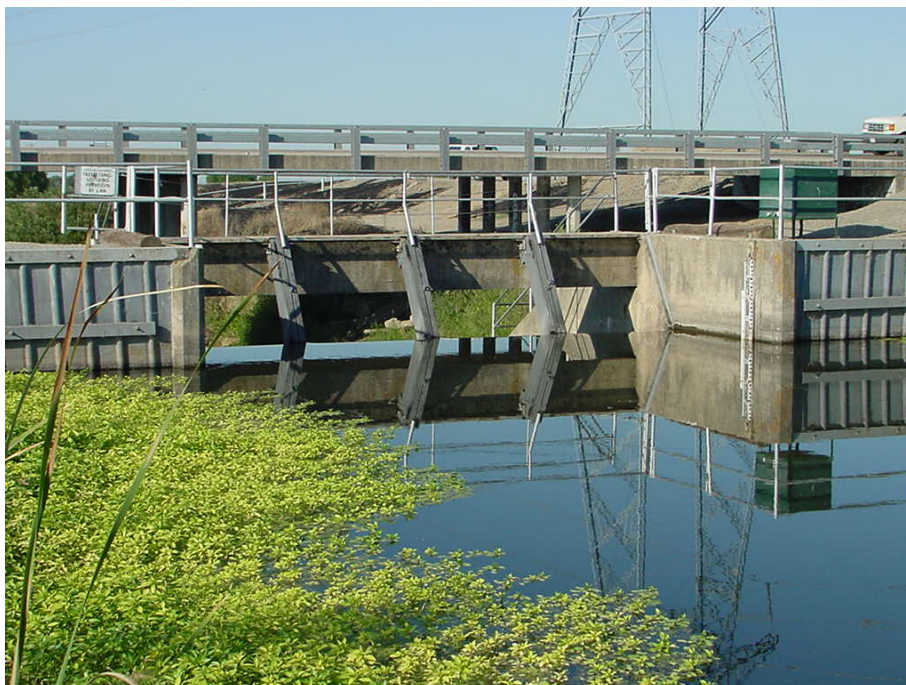
Upstream side of structure from the left bank levee.

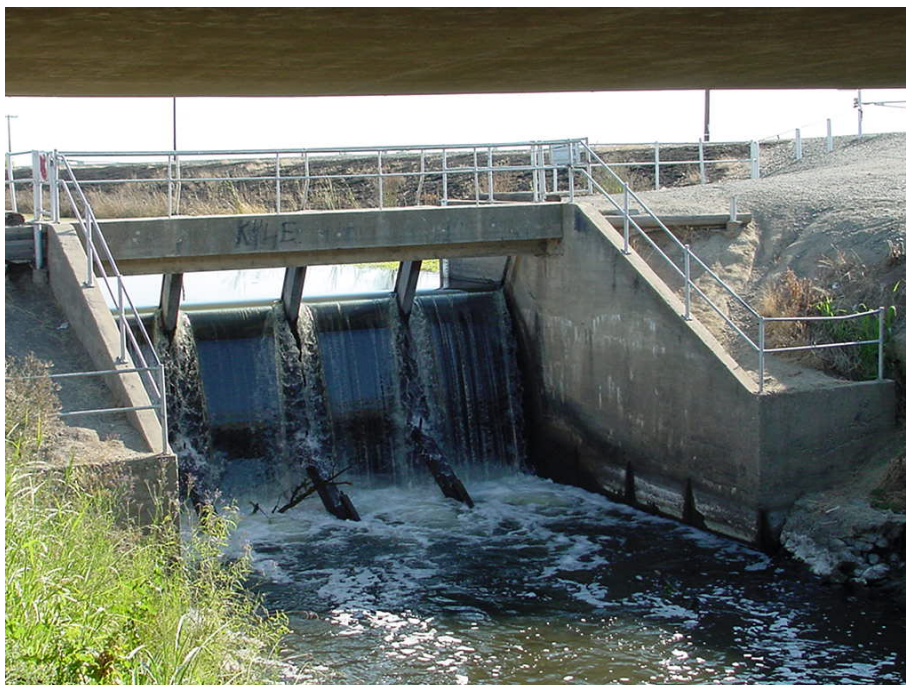
View of the downstream side of structure.

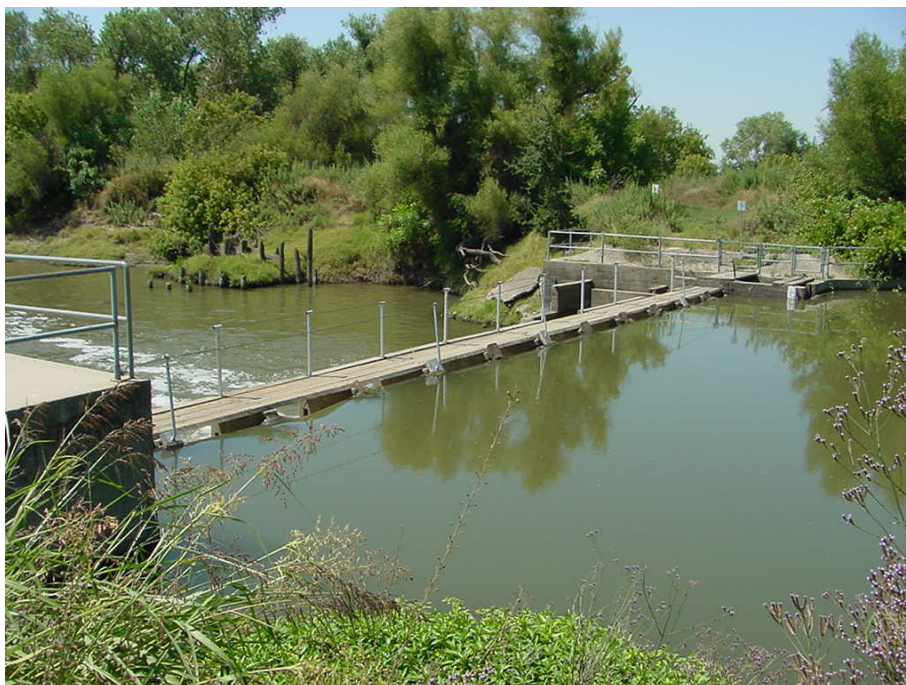
Upstream side of the structure.

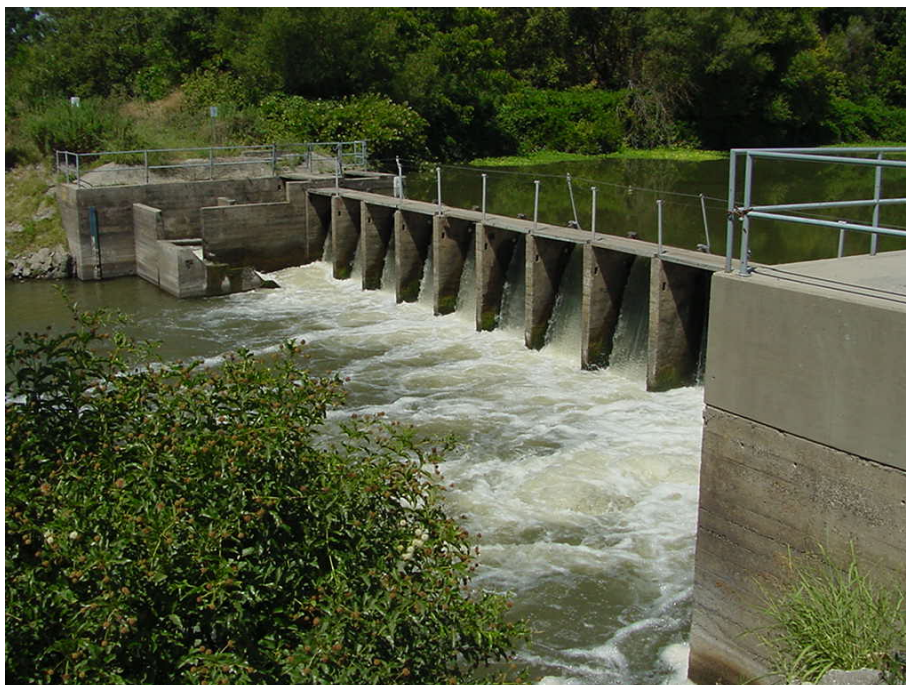
Downstream side of the structure.

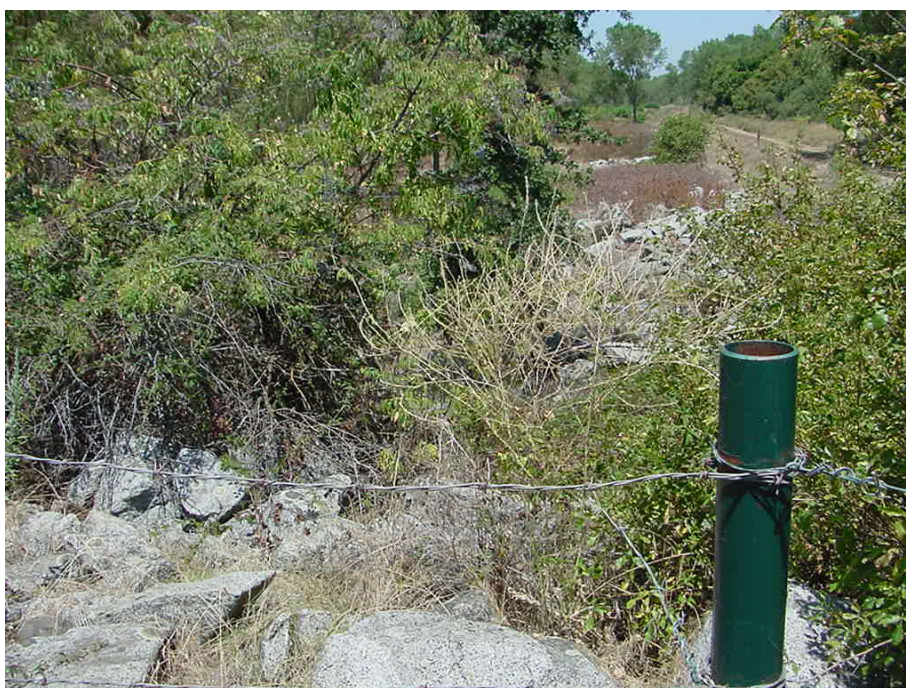
View of the weir from the south/west end.

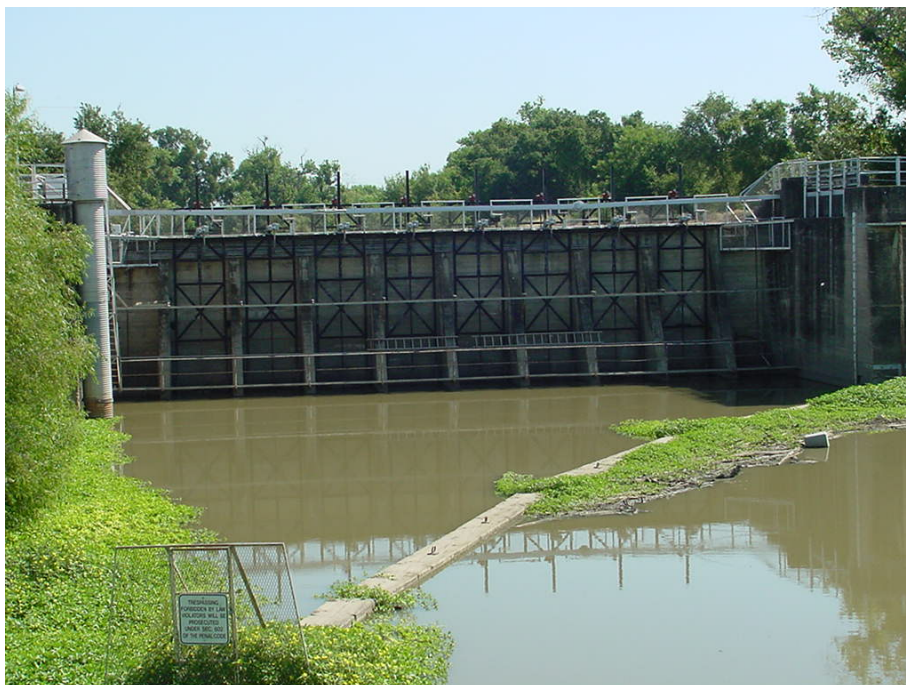
Upstream side of structure from the left bank.

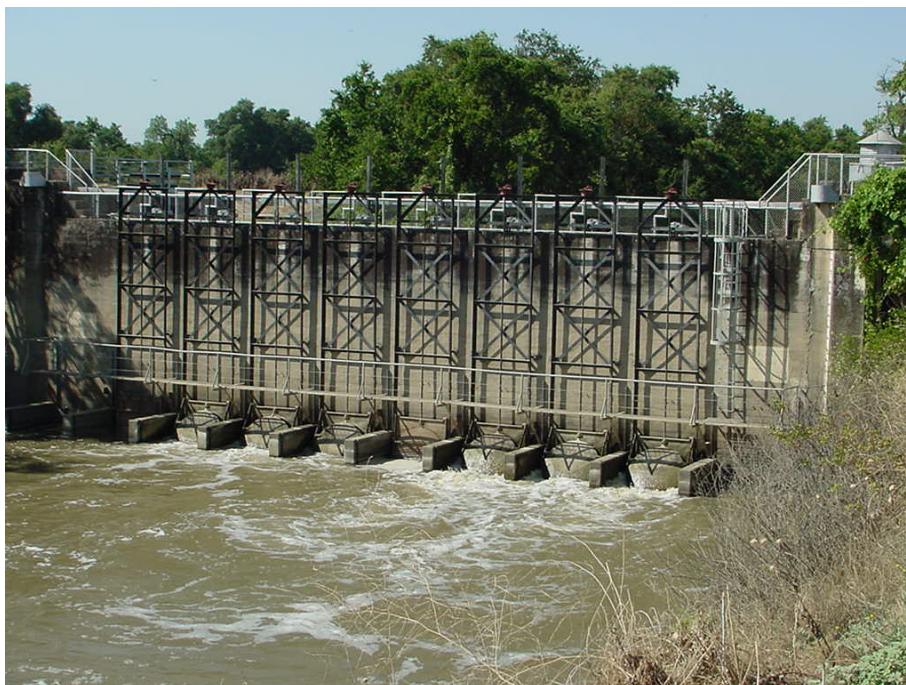
Downstream side of the structure from the left bank.
